DESIGN, FABRICATION, INSTALLATION AND FLIGHT SERVICE EVALUATION OF A COMPOSITE CARGO RAMP SKIN ON A MODEL CH-53 HELICOPTER

D.W. Lowry, and M.J. Rich

April, 1983

SIKORSKY AIRCRAFT

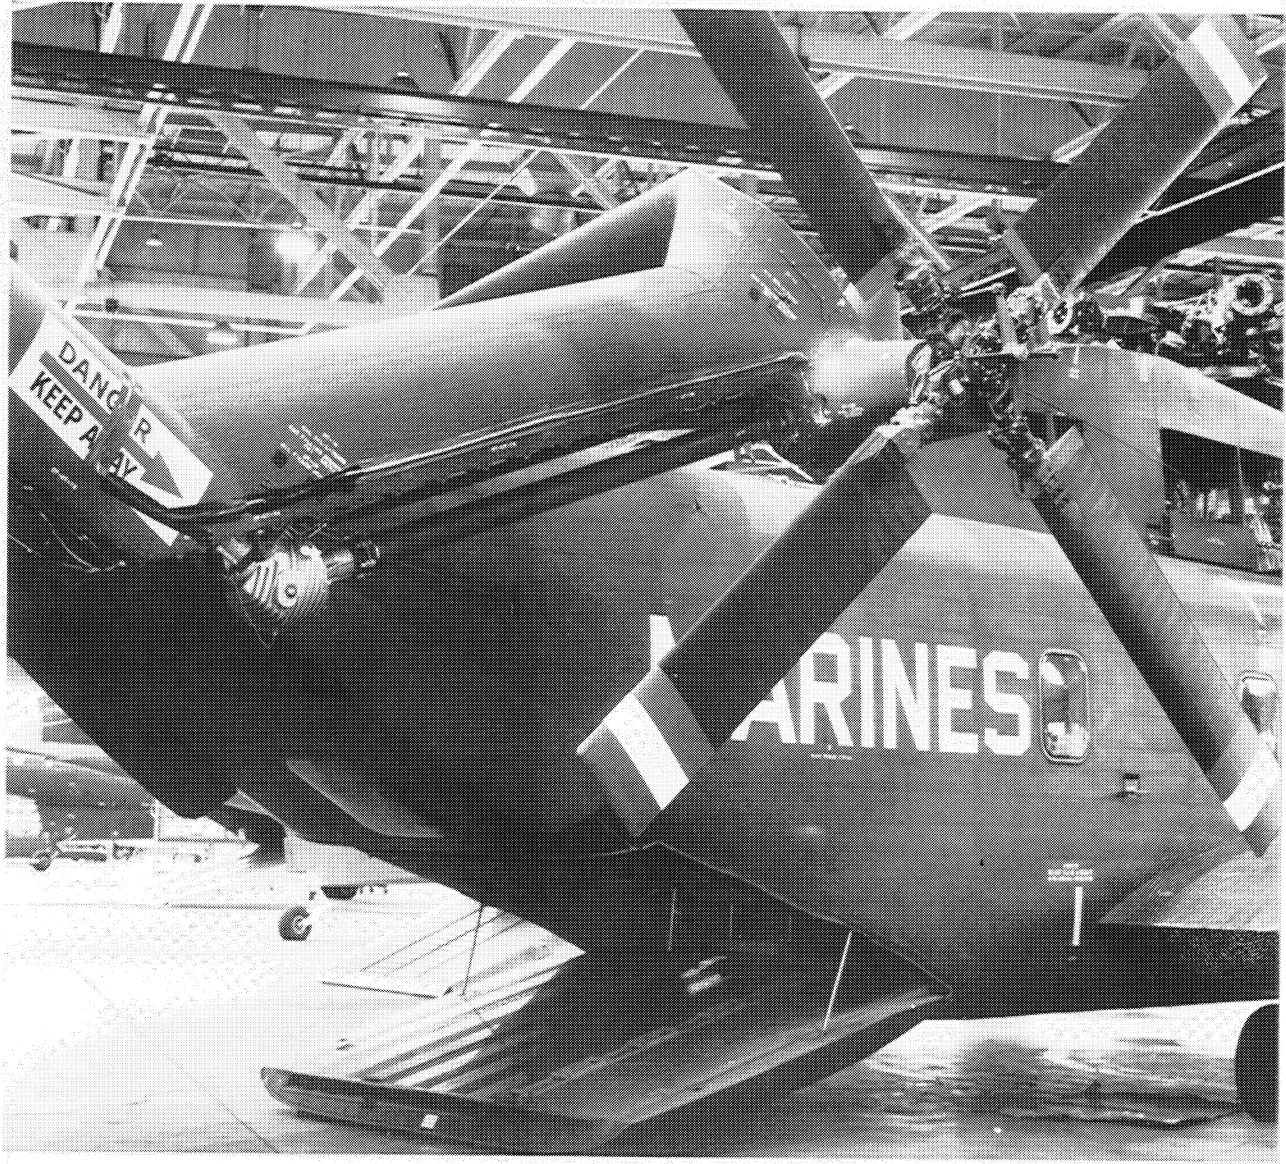
FIGURE 1 CH-53D CARGO RAMP.

There is a need for flight service experience with woven K/E composite material under severe operating conditions. The cargo ramp of the CH-53 Marine helicopter was selected as the candidate structure to assess durability of woven K/E skins. As illustrated in Figure 1, the cargo ramp is located in the aft bottom region of the helicopter fuselage. The aft end of the ramp is subject to possible service damage when it is lowered to the ground for loading. The ramp may also be subjected to damage from ground surface debris.

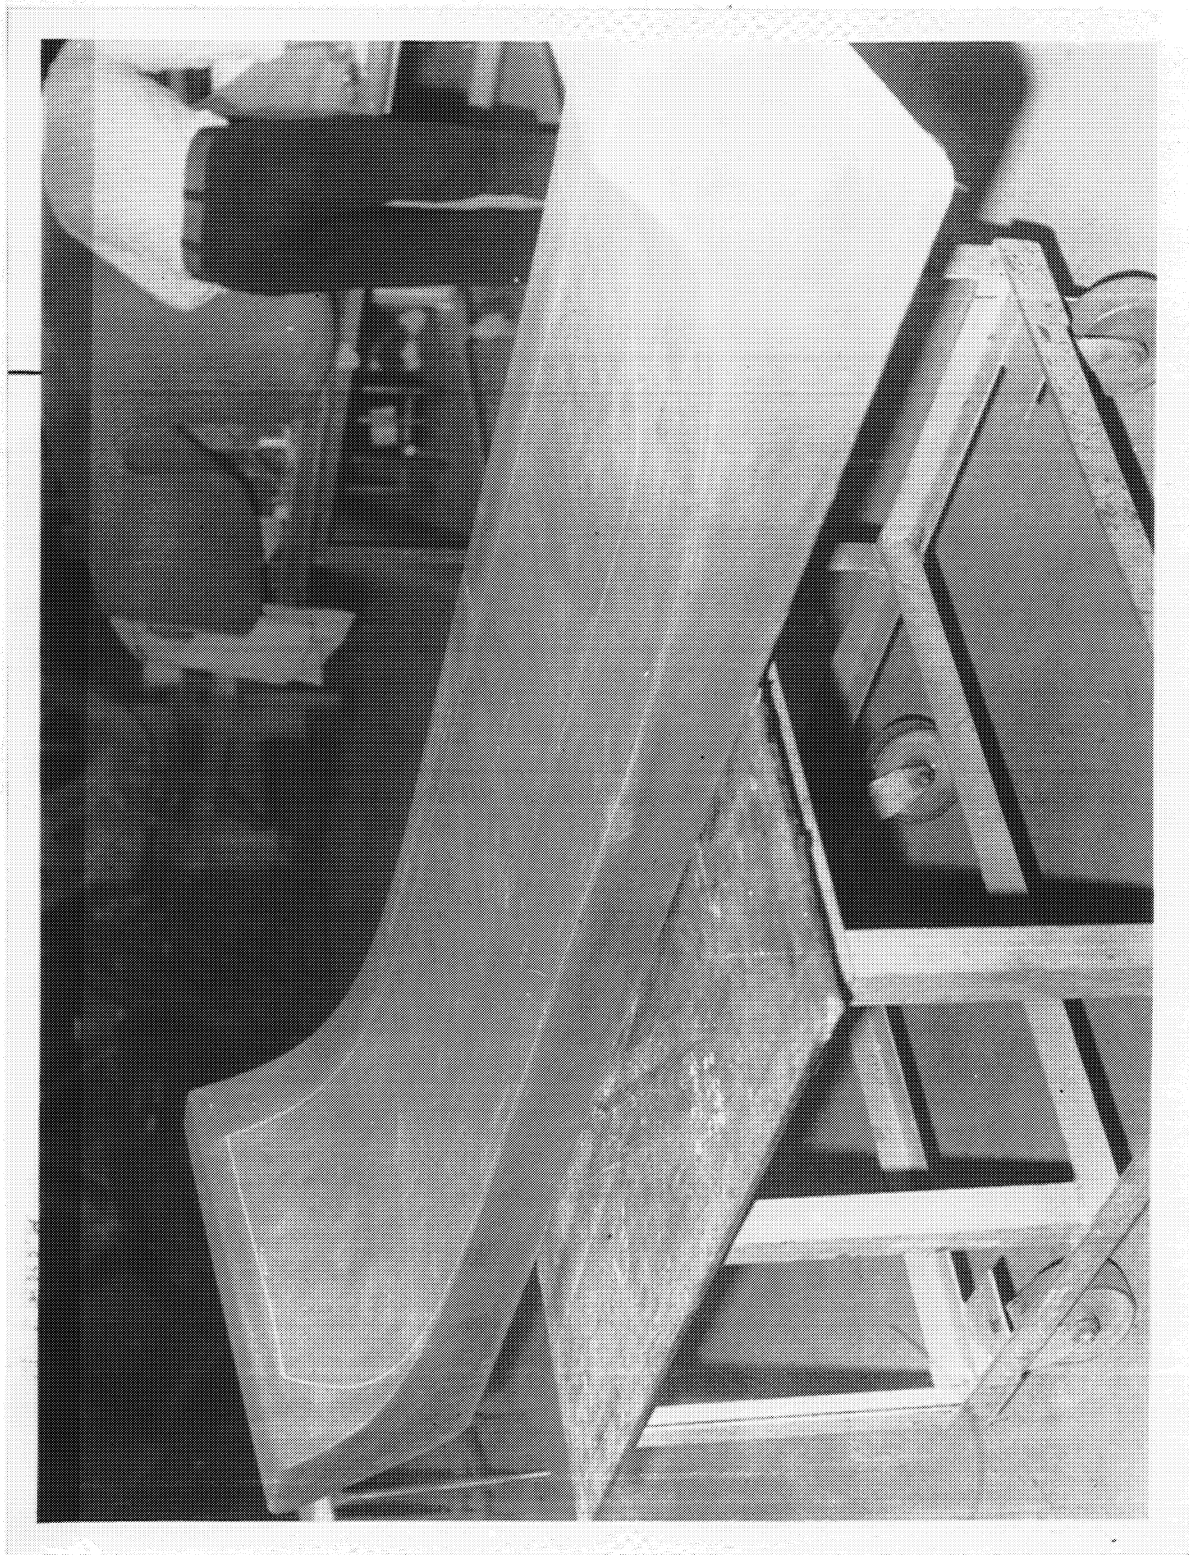
FIGURE 7 EPOXY MOLD FOR KEVLAR SKIN

An epoxy mold, female type, was constructed to the outboard mold lines of the ramp skin. The mold was constructed from a plaster mockup of the CH-53 ramp that has been used to develop stretch forming dies for the aluminum skins. A wax build up was applied to the plaster mockup to simulate the Kevlar skin thickness. Epoxy was applied over the wax and a base was constructed to provide support for the epoxy. Trim lines were then scribed into the mold. The mold extended approximately 100 mm (4) beyond the trim lines. The epoxy mold is shown in Figure 7.
